Army Lodging Wellness Recommendation

Fort Riley - Final Submittal

July 23, 2003

Section 1 Wellness Recommendation

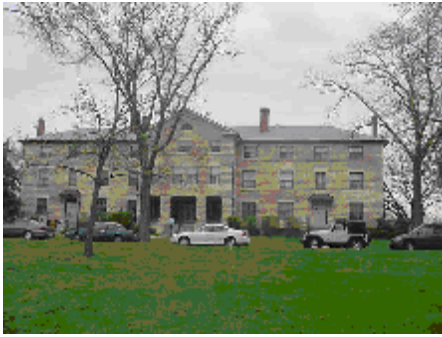
*Building 45
Carr Hall
Fort Riley, KS*

Building 45, constructed in 1904, is an historical structure and is divided into 11 family suites. This facility has three stories plus a basement. Each suite is 545 square feet, consisting of a living room, bedroom, and full bath. In addition to the family suites, this facility houses 7 open office spaces, 20 private offices, and 2 conference rooms. This facility had the HVAC system replaced in 1994. The building is in fair condition but does

not comply with Lodging requirements. The cost to make condition assessment improvements will exceed the 50% replacement cost.

Our recommendation is to remove building 45 from the Lodging inventory, allowing the installation to determine an alternate use for this facility. This facility will be removed from the Fort Riley Wellness Solution and Lodging Master Plan.

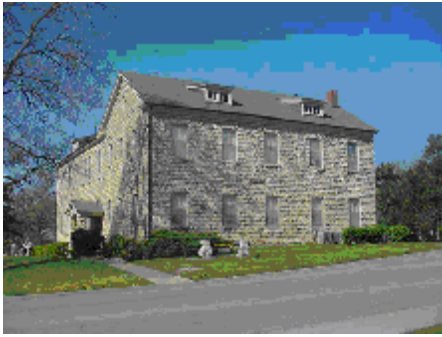
*Building 170
Waters Hall
Fort Riley, KS*

Building 170, constructed in 1888, is an historic structure that is divided into 8 family suites. This facility has two stories plus a basement. Each suite has 732 square feet, consisting of a living room, bedroom, and full bath. The building is in fair condition but does not comply with Lodging standards. The cost to make condition assessment improvements will exceed the 50% replacement cost.

Our recommendation is to remove building 170 from the Lodging inventory, allowing the installation to determine an alternate use for this facility. This facility will be removed from the Fort Riley Wellness Solution and Lodging Master Plan.

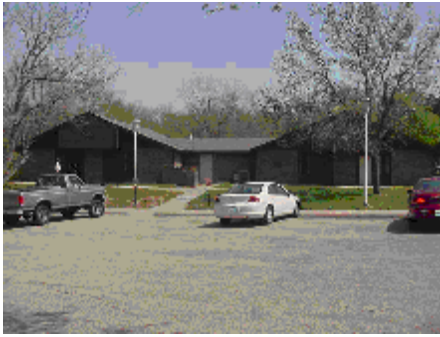
*Building 470
Graham Hall
Fort Riley, KS*

Building 470, constructed in 1972, has 5 family suites. The facility is one story with three 700 s.f. suites, and two 450 s.f. suites, consisting of a living room, bedroom, kitchen, and full bath. The building is in good condition, although it exceeds Lodging size standards. The cost to renovate to meet Army Lodging square footage standards will exceed 50% replacement cost.

Our recommendation is to remove building 470 from the Lodging inventory, allowing the installation to determine an alternate use for this facility. This facility will be removed from the Fort Riley Wellness Solution and Lodging Master Plan.
